Naval Facilities Engineering Command, Mid-Atlantic

Safety Lessons Learned Mishap Abstract

MISHAP : Crane Lattice Boom Collapse
Injury: None
Damage: Crane, Pile Leads and Crane Boom
Estimated cost: over \$250,000
Type of Work: Driving Piles
Equipment: American Crawler Model 9260

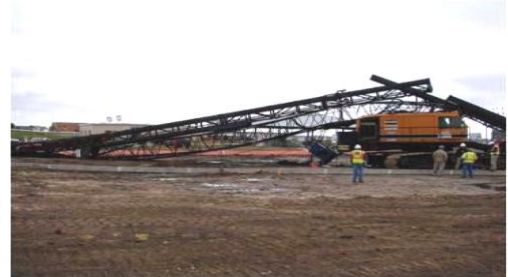
DESCRIPTION OF THE MISHAP: Crane was in position with a 110 foot (12"by 12" concrete pile in the leads when a "pop" was heard. The leads dropped straight to the ground and the boom recoiled backwards and struck the boom stops. The leads followed overcoming the stops and fell directly over the centerline of the crane house. The operator jumped from his station and exited the rig. The 110 foot concrete pile fell independently to the right of the crane. No injuries to personnel occurred

DIRECT CAUSE: Contractor failed to use crane manufacturer OEM equipment when making modifications to crane boom. Contractor failed to have welded connection designed by a Registered Professional Engineer.

ROOT CAUSE: Contractor failed use required manufacturers OEM Head Box for connection of Pile leads to lattice boom.

1. Pile driving attachments must have OEM attachment documentation with the crane.
2. Current Crane Checklists need to be updated to reflect requirement to verify only OEM equipment is installed on all contractor cranes Special Note* Contract Safety Manager collaborating with Crane Surveillance and NAVFAC Safety Contract Safety personnel to ensure checklist are updated to include pile drive attachment points are using OEM
3. Safety Alert will be issued with crane attachment details.
- 4 Determine why current CNRMA crane instruction applies only to Hampton Roads AOR.
